Izhmash Biathlon Rifle Barrel Replacement

Dave Anana

Barrel Manufacture and Installation

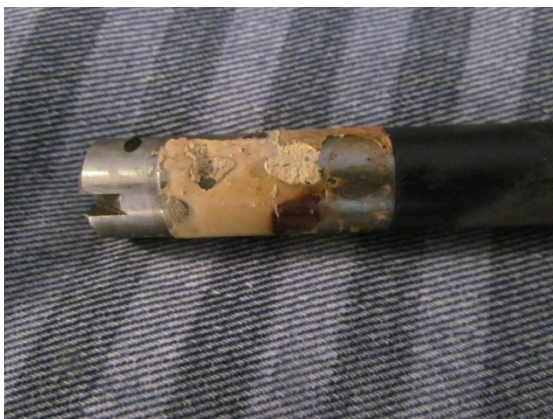
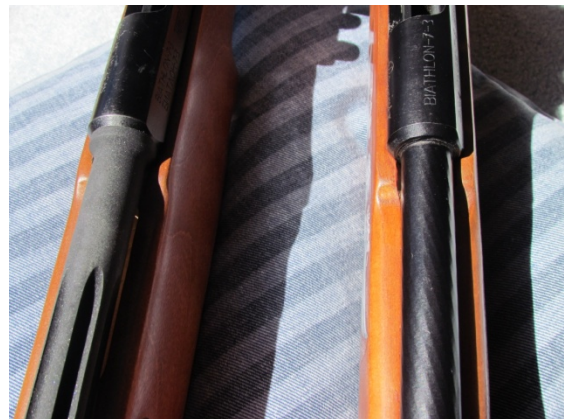
1. The original barrel-to-receiver attachment clamped 0.5-inches of barrel bearing surface supplemented by 1.5-inches of adhesive. It was not a reliably rigid interface; alignment could be adversely affected by very simple actions like grasping the rifle by its barrel. The condition is easily underestimated as it was neither visible nor obvious.

The described barrel replacements eliminated the three major weaknesses to the Izhmash 7-3 and 7-4 rifles modified in this exercise. On a shooting performance level they are now equal to or better than an Anschutz 1827F rifle in its delivery configuration (read close tolerance and fragile). When accounting for maintenance durability, simplicity and ease of dry fire these modified Izhmash units are easier for training and peak shooting performance.

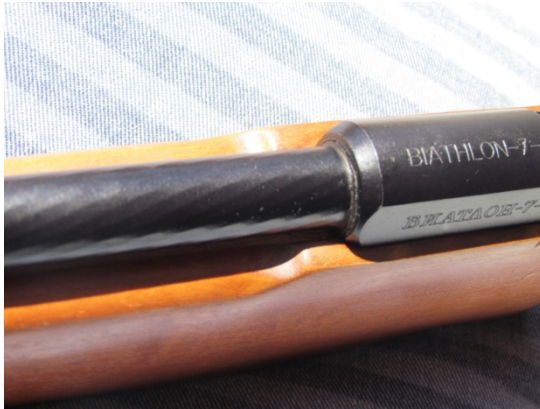
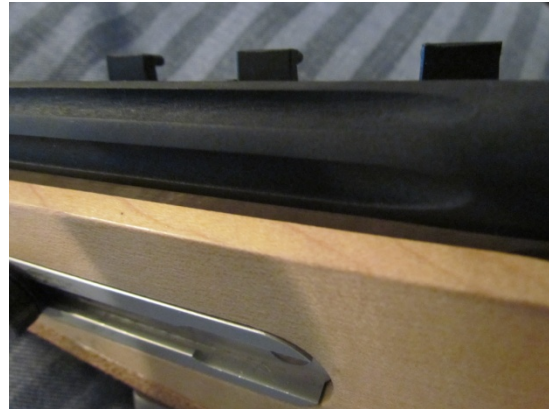
2. Hammer forged barrels on Izhmash rifles retained localized residual stresses from the manufacturing process. Barrel behavior will be unpredictable when subjected to thermal fluctuations because the metal's grains and boundaries vary along cross section and length. Accuracy and repeatability of a good machined, heat treated barrel will always equal or exceed its low cost, high volume, military oriented hammer forged counterpart.

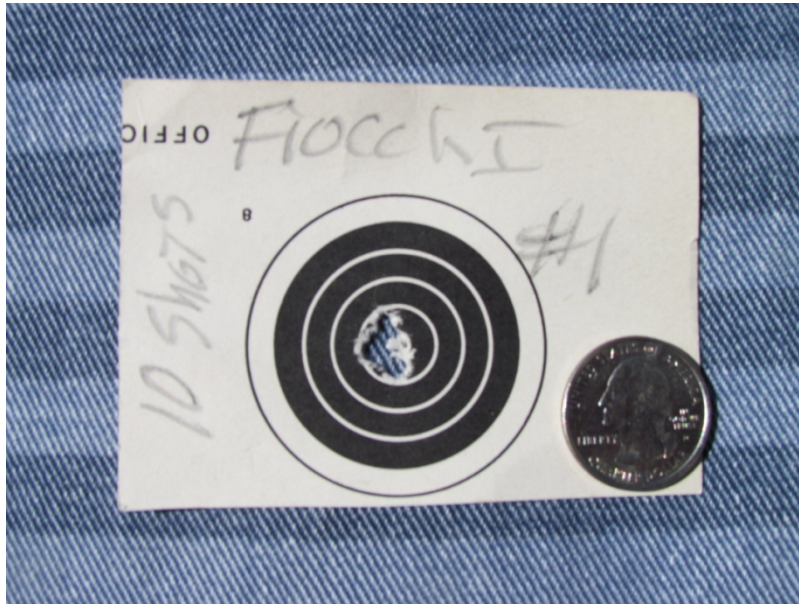
Test results of Eden's 7-3 rifle – Ten shots at 50 feet from a bench rest

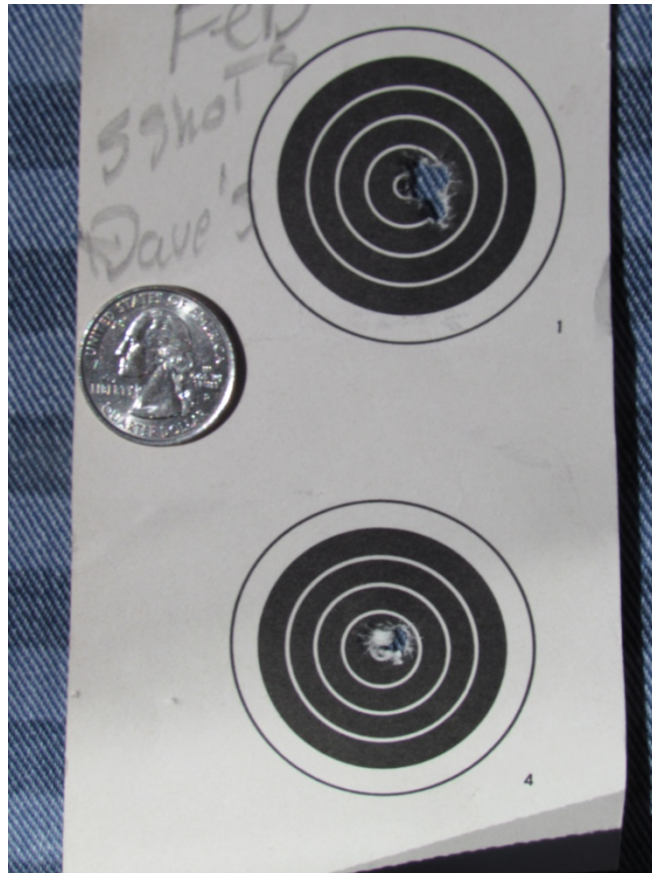
Test results of the 7-4 rifle – Five shots at each target from 50 feet off of a bench rest
